INDEPENDENT AUDIT

TRIESTE 3D SEISMIC SURVEY

FEBRUARY 2020
Report No. 01229F_1_v2

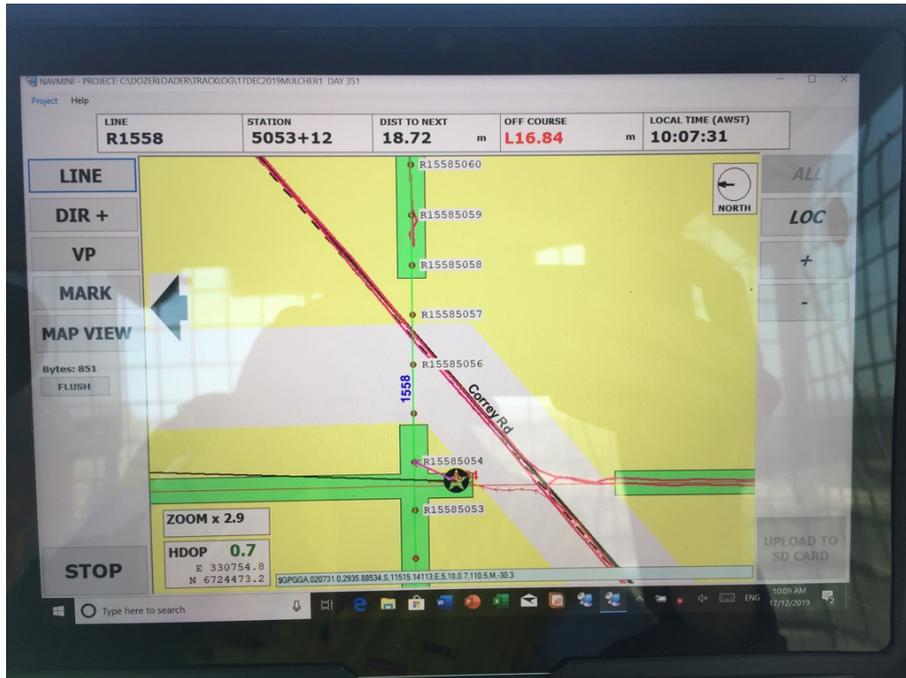
Plate 1: GPS navigation system used on mulcher indicating where mulching (green rectangle shape) is to occur. Note that when approaching a road no mulching is undertaken.

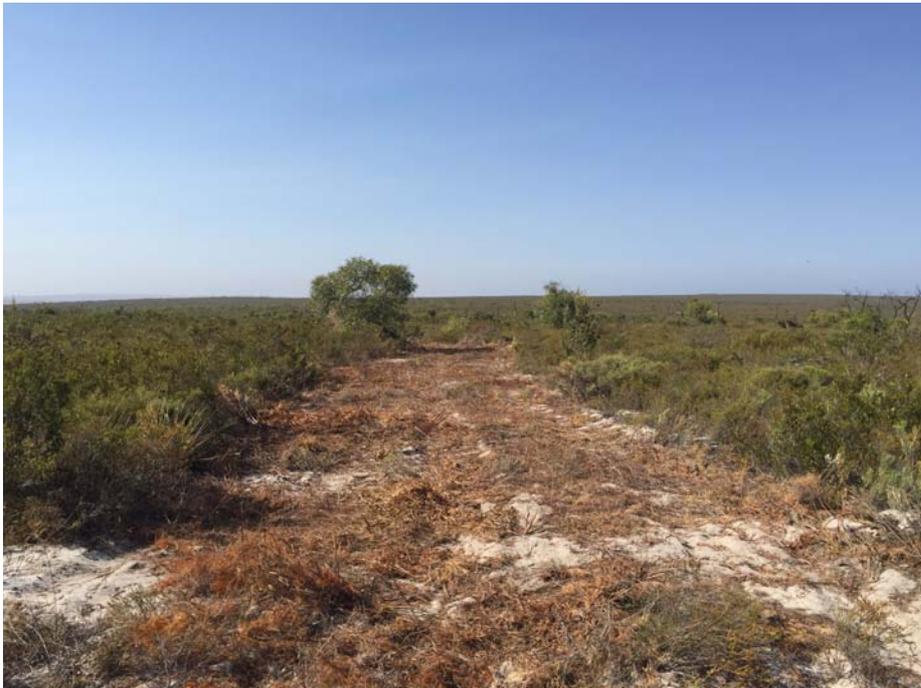
Plate 2: Source line.

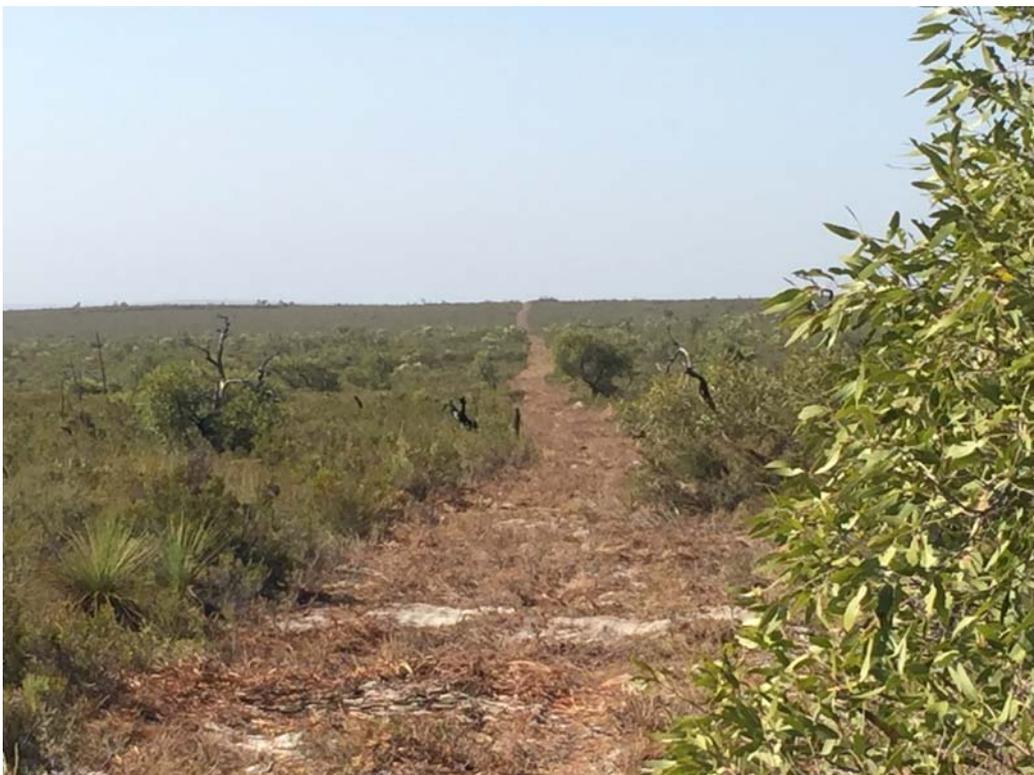
Plate 3: Standard Receiver line.

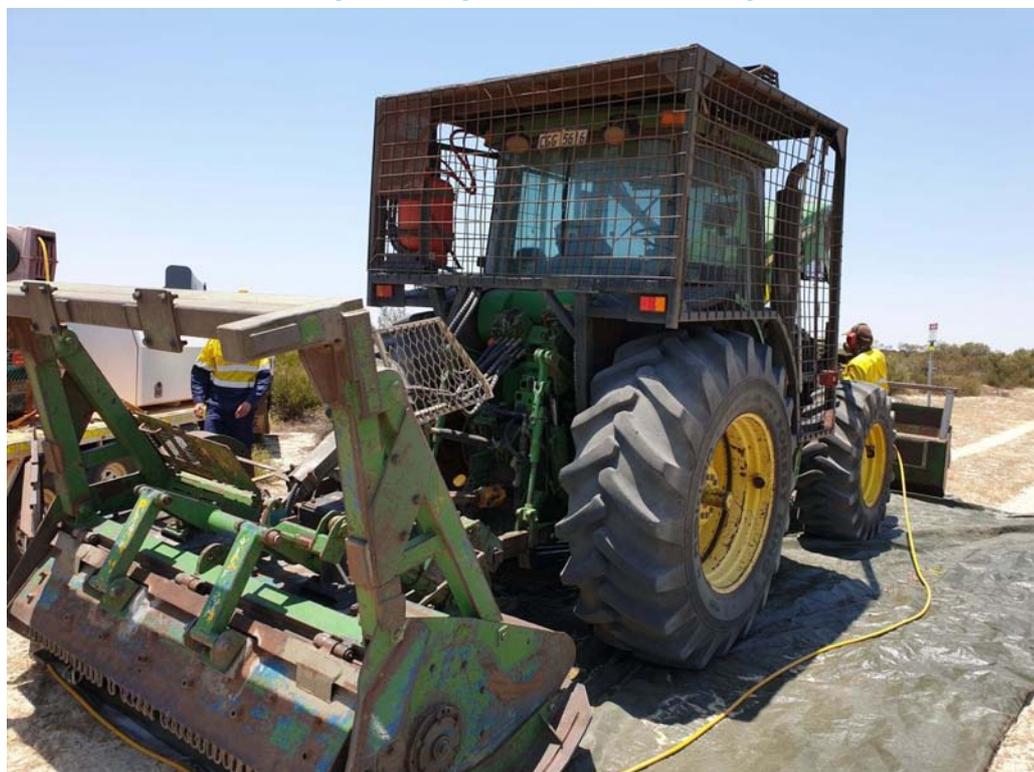
Plate 4: Mulcher being blown down prior to entering private property to continue undertaking mulching of remnant native vegetation.

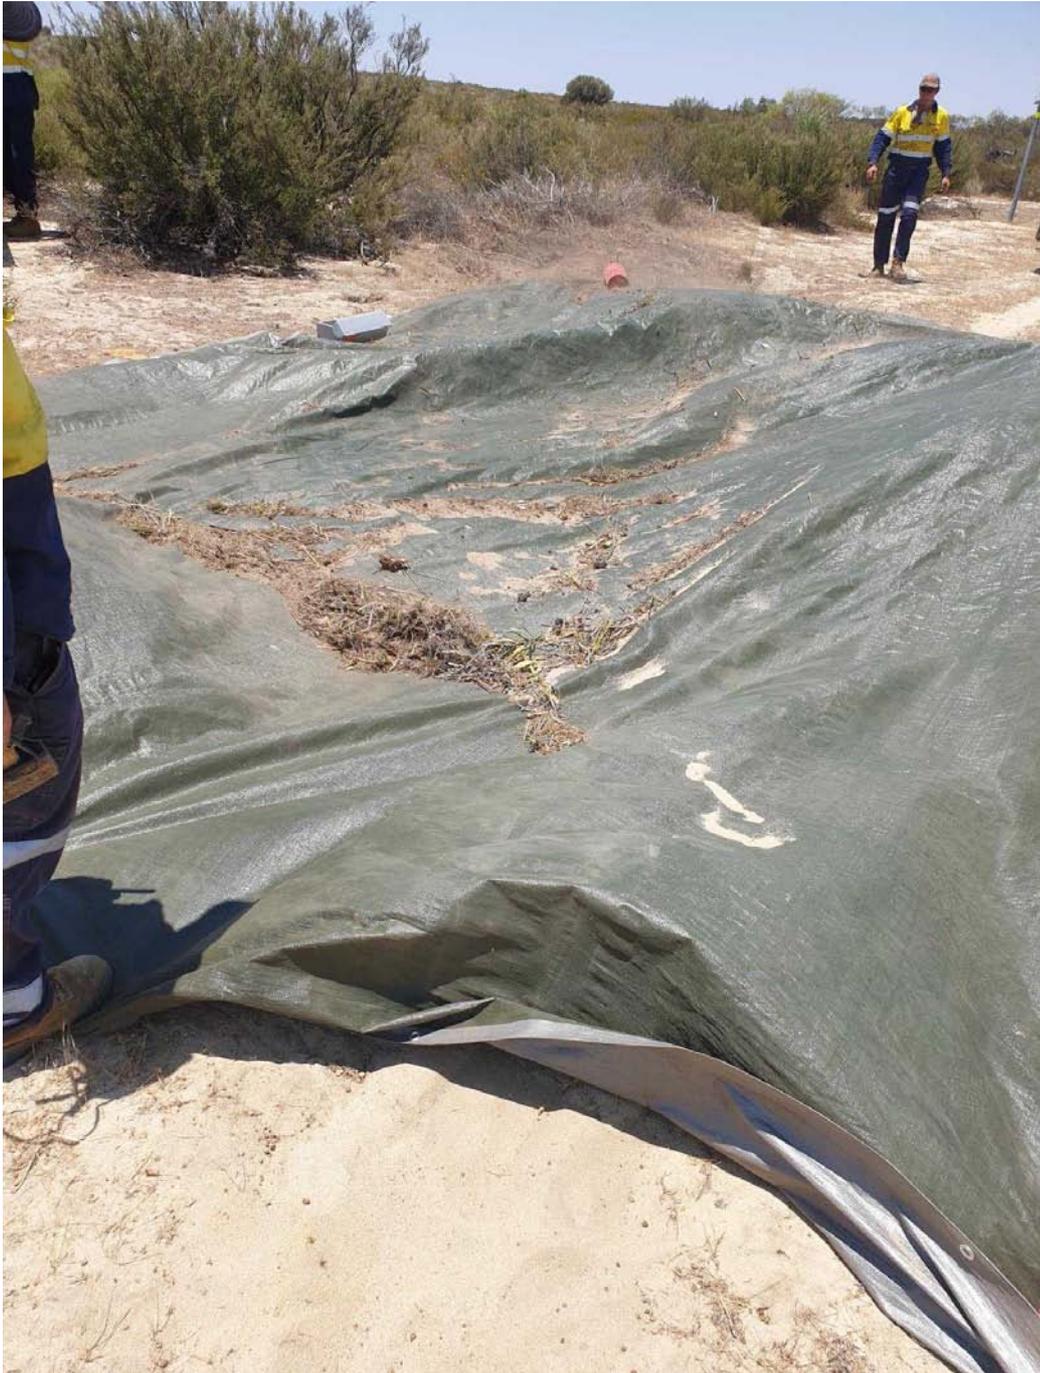
Plate 5: Material collected following Mulcher being blown down.

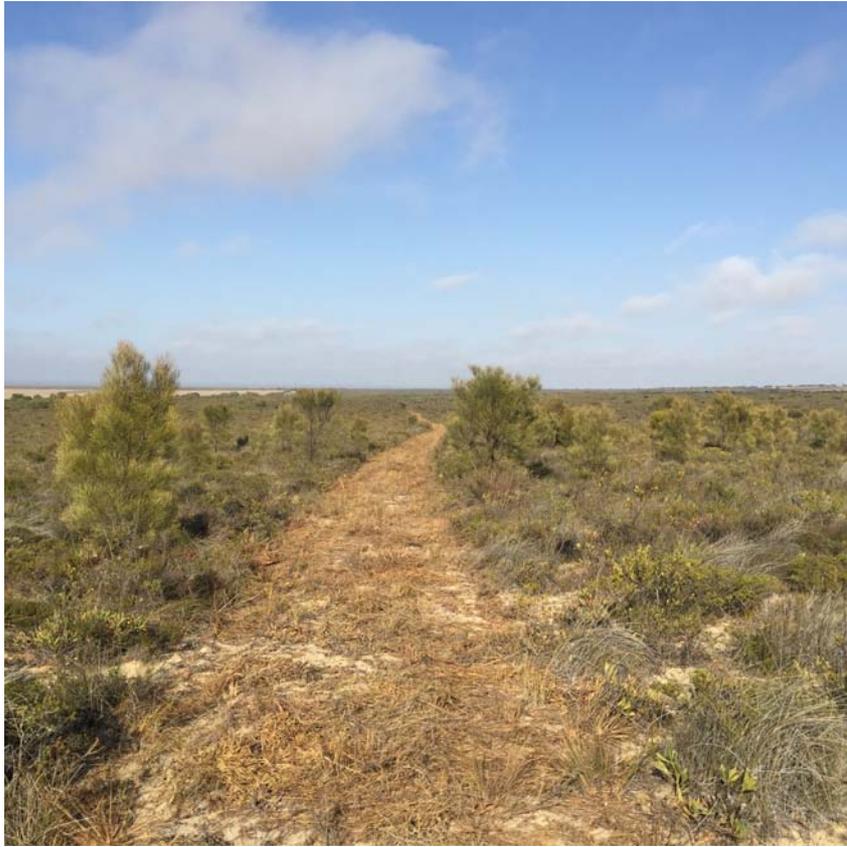
3	EPBC 2017/8133 Condition 3	Verification Method	Evidence	Documents Sighted	Determination	Compliance Finding
3.1	Criteria: Retain the vegetative material removed by clearing.	Site inspection	Vegetative material was mulched in-situ (Plate 6).	Not applicable	Mulching of seismic lines was shown to be very effective with no material being removed and all vegetation remaining in-situ.	Compliance

Plate 6: Mulched material left in-situ.

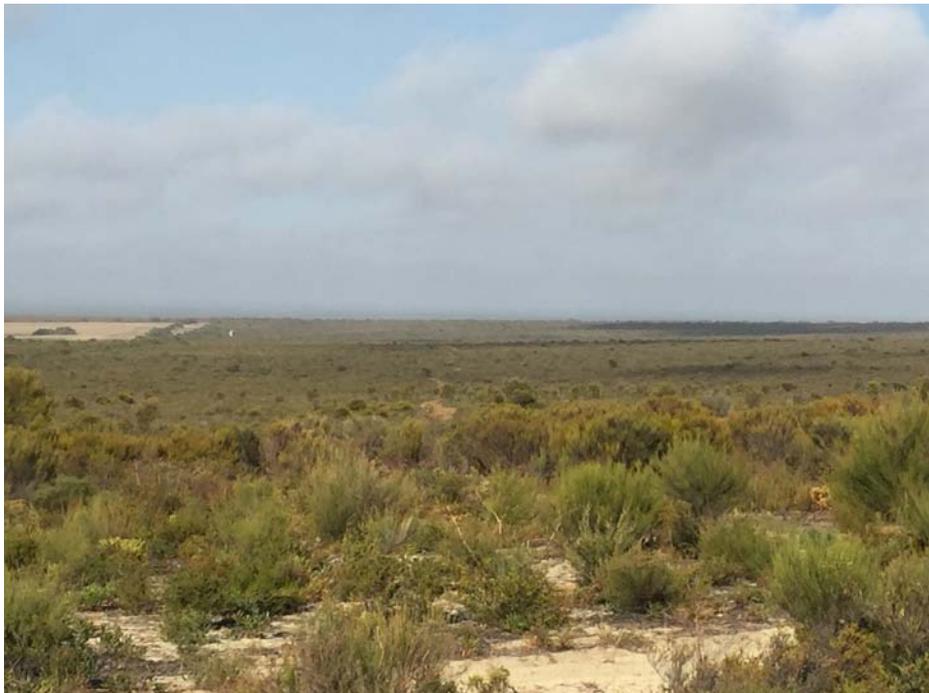
3.5	Criteria: Implement adequate measures to prevent third party access to survey lines and access tracks.	Site inspection	Within 20m of public roads the mulcher was raised so that third party access is not encouraged. As the area is mulched the terrain is difficult and does not encourage third parties as the likelihood of puncturing a tyre is high due to the numerous sticks that protrude after the mulching. In a limited number of occasions, the mulcher was not raised, and mulching occurred up to the fire access track. This issue was observed on the first day that mulching occurred and had not occurred since.		Management practices have been implemented to prevent third party access. These include: <ul style="list-style-type: none"> • Entering information into GPS to mark seismic lines and access tracks which identifies when mulcher is to be lifted (Plate 1). • Lifting of mulcher 20m before Public roads (Plate 7). Beach Energy also intend to erect signs stating 'Rehabilitation in Progress' at selected seismic lines once the program is complete.	Compliance

Plate 7: Vegetation not mulched before public roads.
